Environmental Response and Recommendations Report

Coats American, Inc.

Coats American-Sevier Plant

Marion, NC

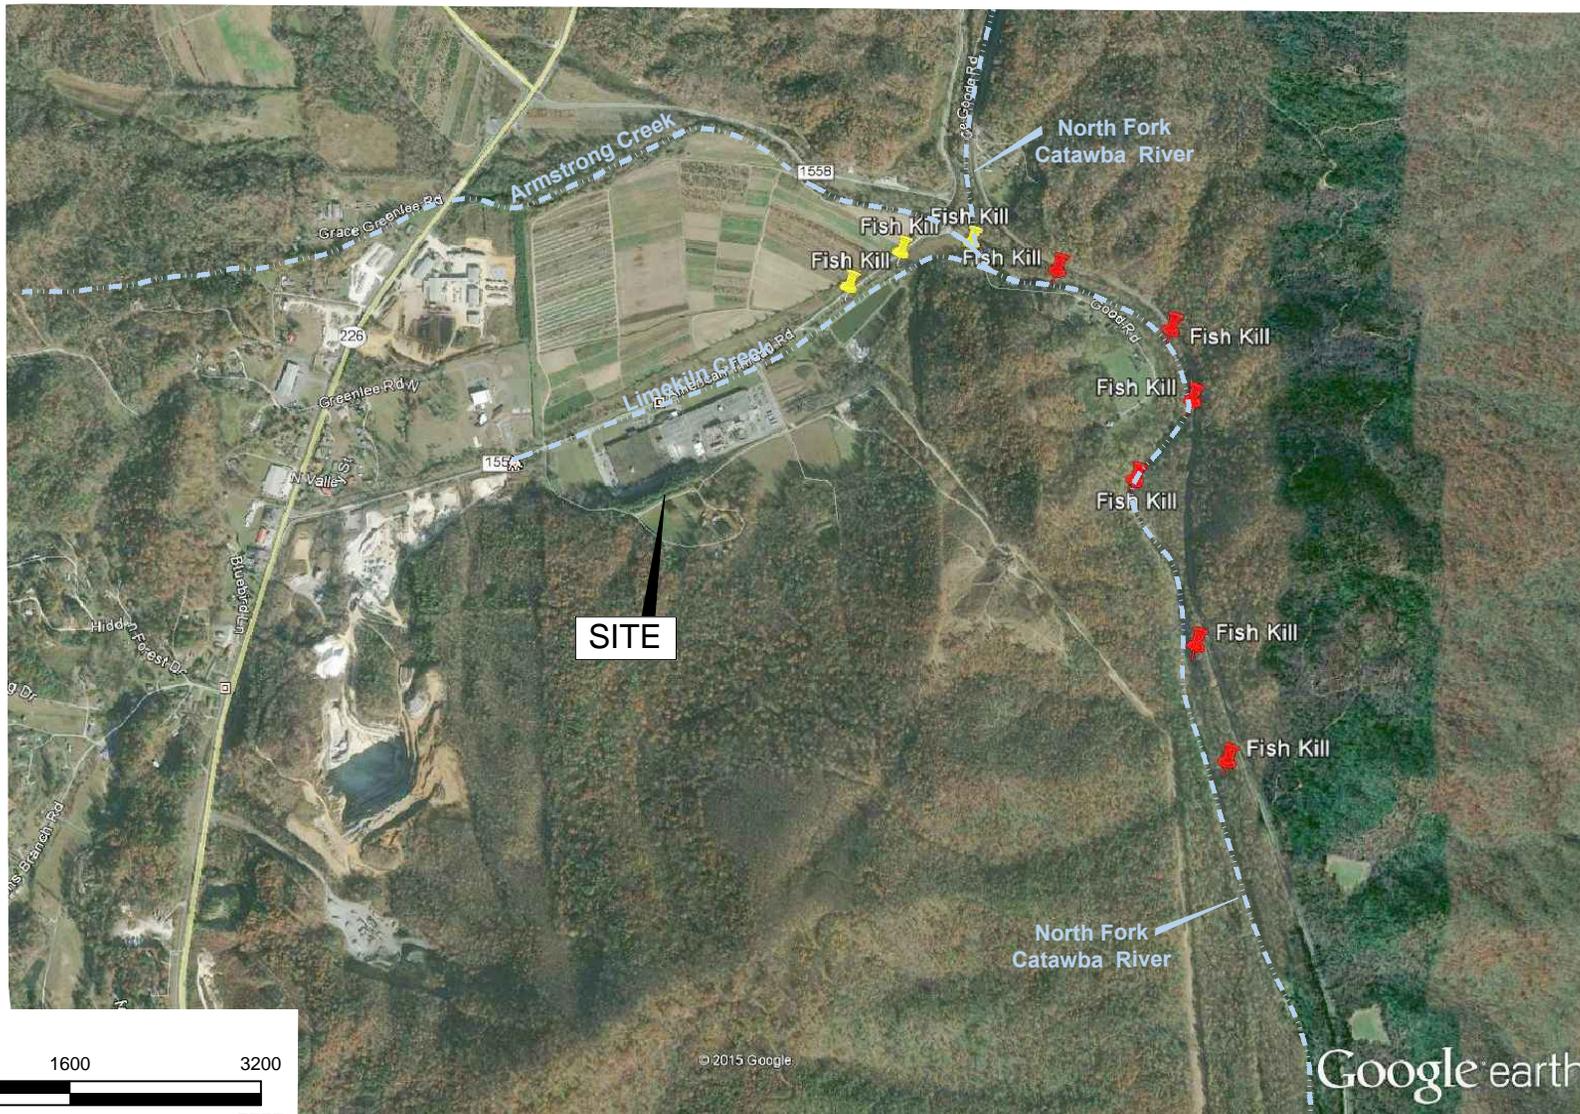
FIGURE 2
 LOCATION OF DOCUMENTED FISH KILLS
 Environmental Response and Recommendations Report
 Coats Sevier Plant
 Marion, North Carolina

Fish kills were noted along the North Fork of the Catawba River and on Limekiln Creek (down-gradient of the Coats American Outfalls 7 and 8). Figure 2 provides the location of documented fish kills. A verbal report was provided (on July 10th, 2015) that NCDENR personnel also observed fish kills up-gradient of the beaver dam along the unnamed tributary on the Coats American property. As a result of these evaluations and observations, the source analysis focused initially on the location of the WWT basin and the beaver dam. However, ERM also investigated up-gradient of the beaver dam, as is set forth more fully below.

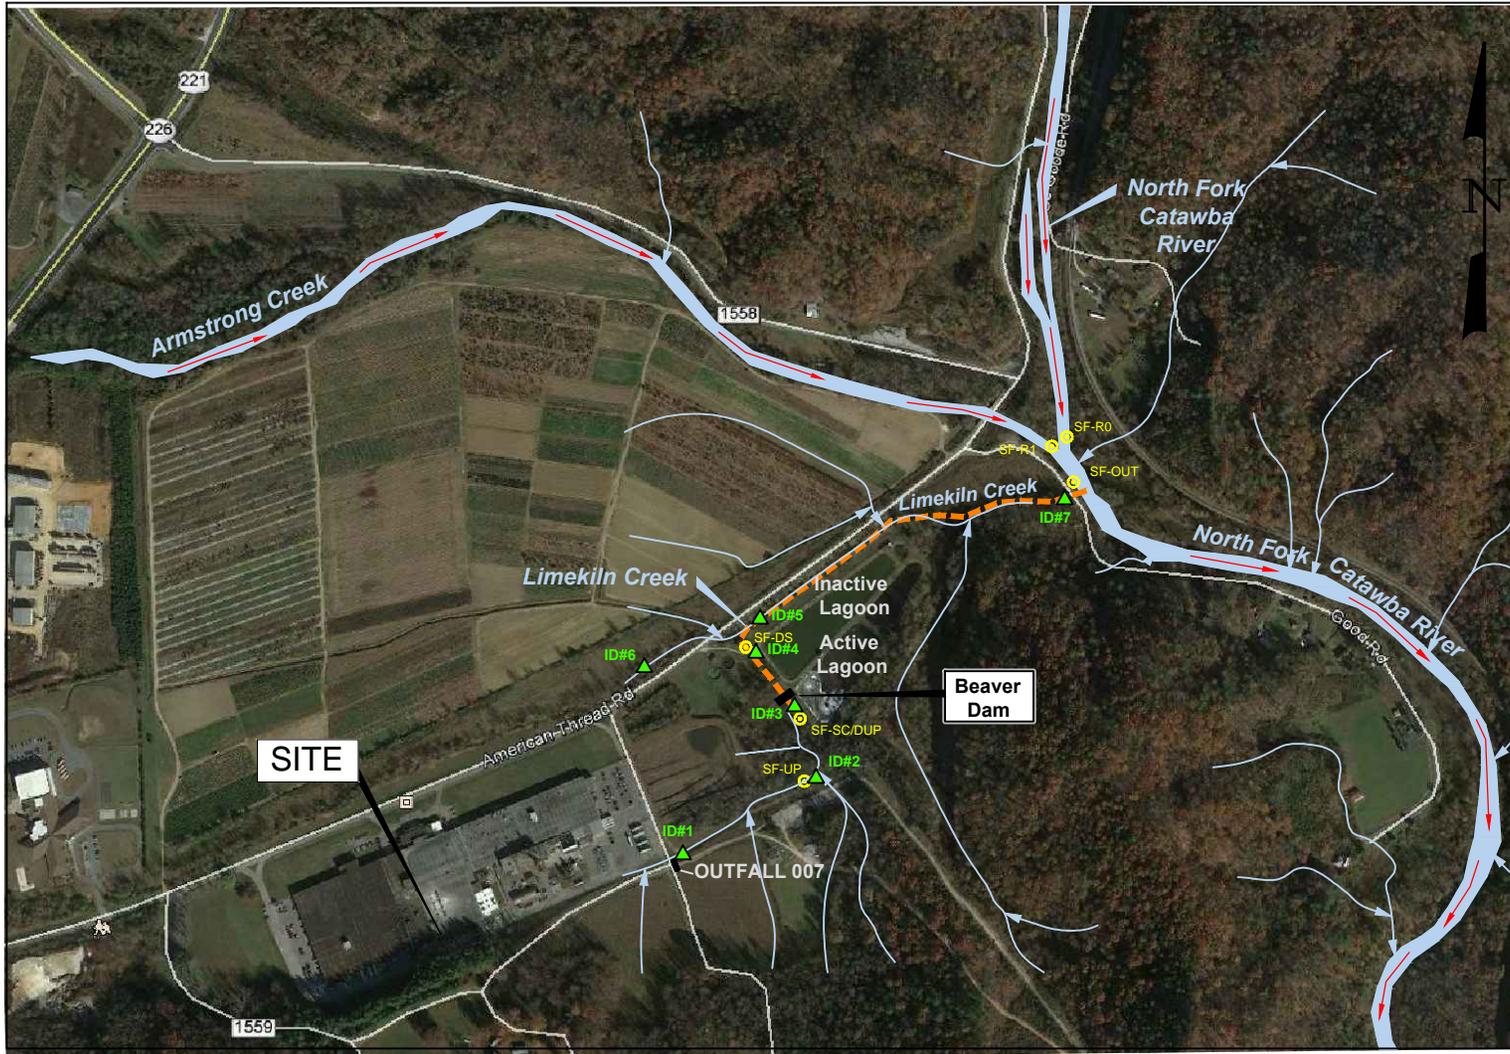
FIGURE 4
FACILITY DRAINAGE MAP
Environmental Response and Recommendations Report
Coats Sevier Plant
Marion, North Carolina

Figure 3 presents a watershed map depicting EPA's sample locations along the North Fork of the Catawba River. Figure 4 provides a Facility Drainage map, showing the local drainage to the North Fork of the Catawba River, and notes sample locations on-site critical to the ongoing investigation.

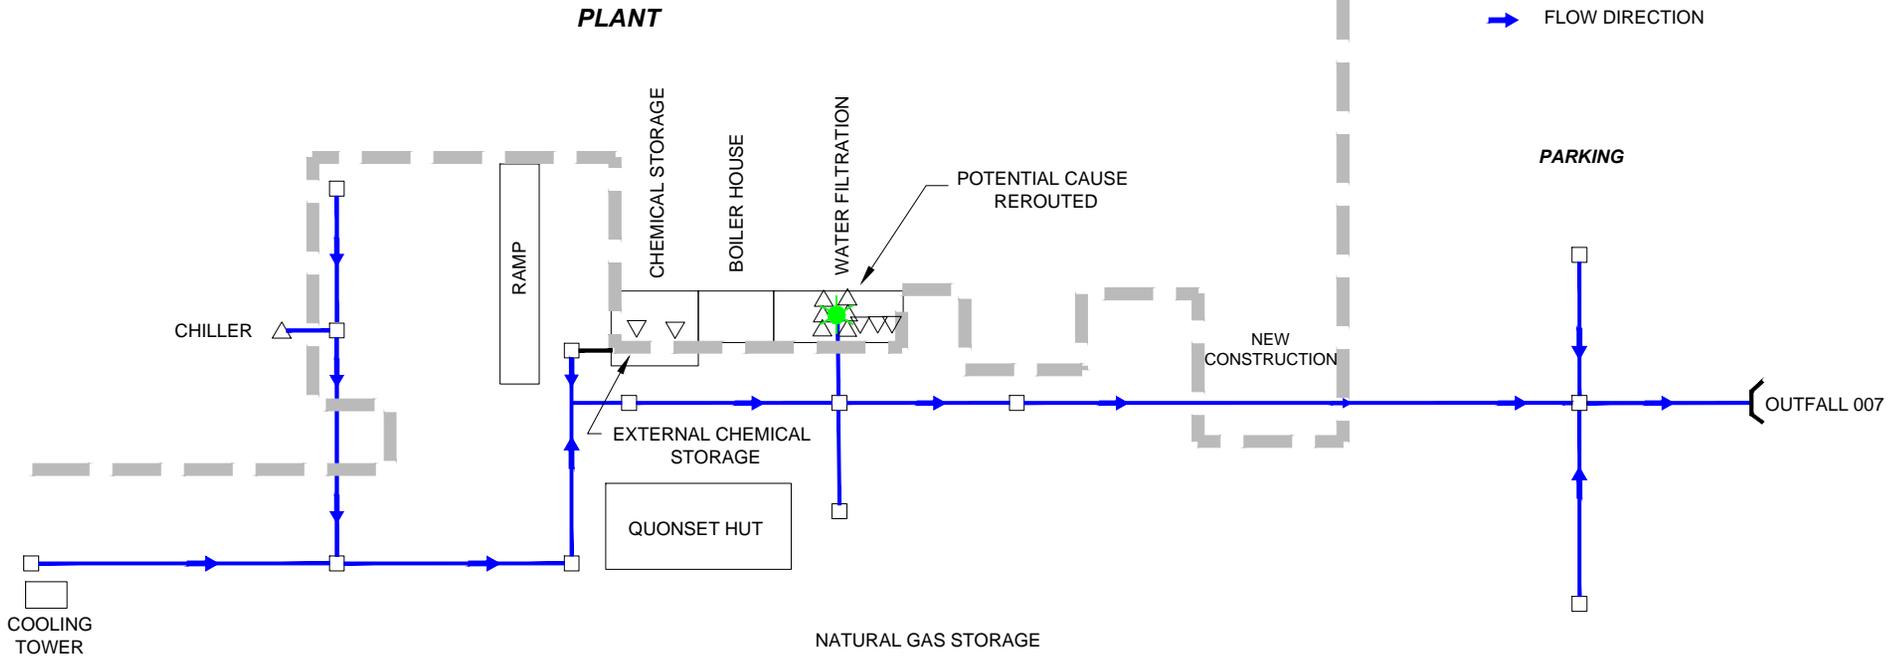
FIGURE 5
 STORM DRAINAGE SYSTEM (OUTFALL 007)
 Environmental Response and Recommendations Report
 Coats Sevier Plant
 Marion, North Carolina

On July 10, 2015 ERM reviewed original 1951 plant drawings for the storm water drainage systems. In addition, ERM conducted a local area review and found continuous discharge occurring from Fire Water Pond overflow. **Figure 5** presents a graphic showing possible inputs into the storm drainage system up-gradient of the WWT area from Coats American property. The map indicated numerous surface water inputs in the form of local area catch basins. In addition, the 1951 map indicated numerous floor drain connections from within the plant. Facility personnel reported their understanding that all floor drains within the plant had been connected to the waste water treatment system within

The 1951 facility map showed the storm drainage system layout up-gradient of Outfall 007. External plant areas were observed where local storm water could enter the storm drain system. Flow was occurring in each of the storm drains leading up to the chiller discharge storm drain. See Storm Drainage system map Figure 5. The observations external to the plant did not produce evidence of a recent spill or other condition that could be a likely cause of the event. Once the external observations were completed ERM conducted inspections of internal plant sources that could explain a potential release from the storm drainage system.

Because of the connection of certain floor drains in the filter plant area to the storm drain (previously thought to connect to waste water treatment), the observed piping repairs in the filter plant area, and floor cleanup activities, this area (water filtration plant) was identified on July 11th, 2015 as a potential cause area requiring additional follow up. Based on these findings, immediate steps were taken to interrupt potential discharges to these floor drains. In addition, Coats American has retained contractors to promptly connect all of the floor drains in the filter plant to the wastewater treatment system.

On July 14th, 2015 Coats American maintenance staff re-routed the floor drain in the upper level of the water filtration plant to a 55 gallon drum, to eliminate the potential for discharge from the chemical storage to storm drainage.

Containment vessels have been installed beneath the chemical storage tanks. In addition, Coats American has retained contractors to connect all floor drains in the filtration plant to the wastewater treatment plant.
